Results from portable Intermittent Fault Detector (IFD) Testing of Electrical Wiring Interconnection Systems (EWIS)

Weapon System: AH-64 Apache

Unit Under Test (UUT): Black Engine Harnesses

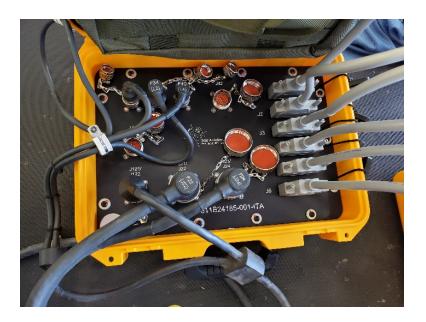
- Left (Cable ID: W185) AutoMap[™] completed
- Right (Cable ID: W186) AutoMap[™] completed found two additional connections different than Left (Cable ID: W185)
 - o Connection #1 was J121 Pin 4 to J121 Pin 10
 - Connection #2 was shield on J21
- Left (Cable ID: W185) Continuity failed due to additional connections as described above
- Left (Cable ID: W185) Intermittence test passed certified intermittent free
- Right (Cable ID: W186) Continuity passed
- Right (Cable ID: W186) Intermittence failed on J39 2,3,4, and shield
 - Lock ring had been overtightened causing poor engagement

Fault Isolation Graphic displaying Intermittent Events on connector J39 wires 2, 3, 4 and shield

- Based on CONOPS, it is recommended that all AH-64 Black Engine Harnesses be quality inspected with IFD prior to install
- Expand IFD testing to additional AH-64 EWIS
