Intermittent Fault Detector™ (IFD-256™)

Customer Removed – Boeing 777 GE90 Engine Harness Wire Bundle Assembly 286W0751-302 / 286W0752-302 Test Summary

18 March 2020

Wire Bundle Assembly (286W0751-302 / 286W0752-302) S/N: 6693415

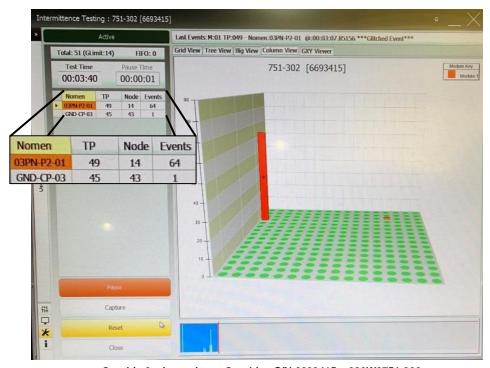
Graphic 2 - Intermittent Graphic - S/N 6693415 - 286W0751-302

- 1. IFD-256 Continuity testing conducted no open circuits present in the UUT
- 2. IFD-256 Shorts testing conducted no shorted circuits present in the UUT
- 3. IFD-256 Intermittence testing conducted multiple intermittent events (64 discrete intermittent events) detected on 03PN-P2-01, Test Point (TP) 49, Node 14 with light, manual manipulation of the harness (see Graphic 2); P2 connector with intermittent events can be viewed in Graphic 3 and 4. One intermittent event detected on GND-CP-03, TP 45, Node 43.

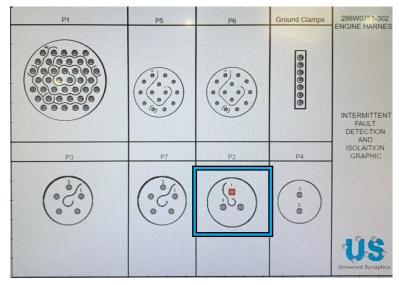
Graphic 3 - Fault Isolation Graphic - P2 Connector with intermittent fault

The same test procedures were followed with the same intermittent results manifesting on Connector 03PN-P2-01, Test Point (TP) 49, Node 14. The ability to conclusively replicate the same intermittent faults the next day indicates that the test subject wiring harness on the GE90 engine will most likely fail in operation.

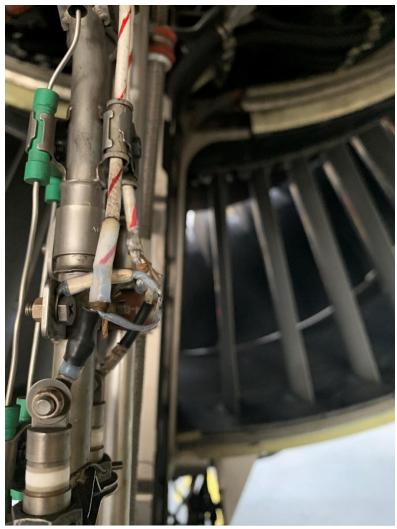
Graphic 9 – Wire Assembly installed on GE90 Engine – excessive wire bend prone to degradation and intermittence
