# Intermittent Fault Detector™ (IFD™)

**[REDACTED] V2500 Engine**

## **VIFD Test Findings Summary**

## V2500-A5 Training Engine S/N: V10045

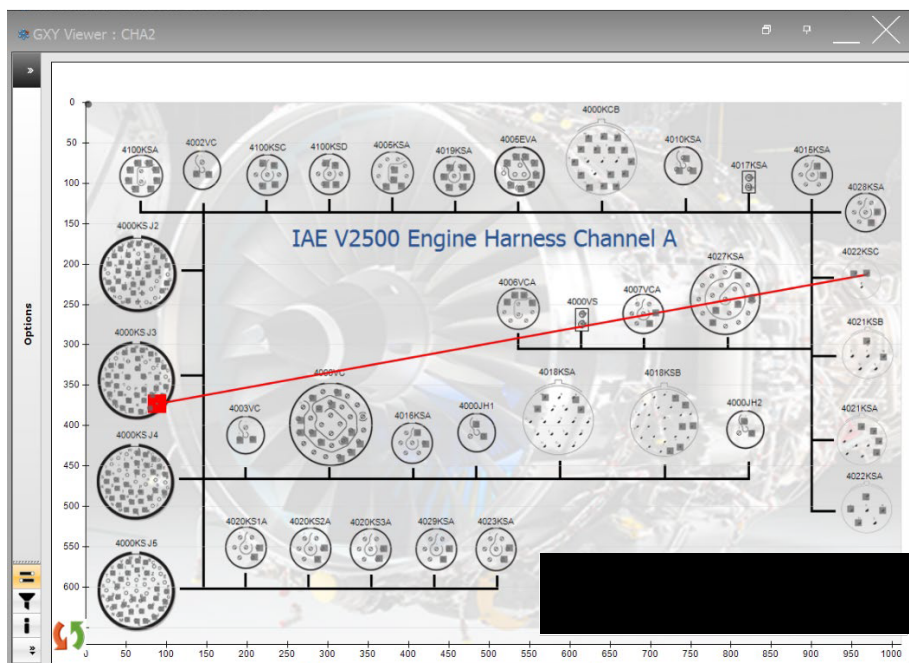
Graphic 1 - Fault Isolation Graphic - S/N: V10045 Engine Harness Channel A

- Voyager continuity testing was conducted, and no open circuits were found in the engine.
- Voyager shorts testing was conducted, and no shorted circuits were found in the engine.
- Intermittence testing was conducted, and one circuit experienced 12 intermittent events on Channel A.
  - Location: Connector 4000KS, J3-H, Wire 77, Connected to Node 70 (Graphic 1 and Graphic 2)

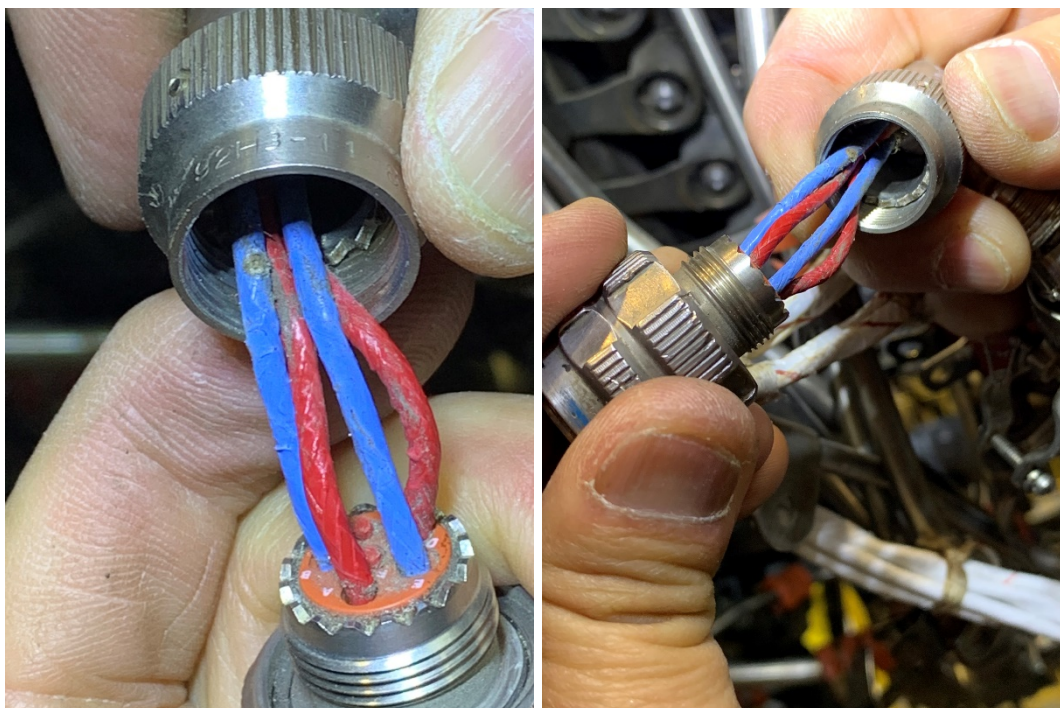
- b. Root Cause Analysis: [REDACTED] engineer was able to diagnose the intermittent fault to root cause base on the Fault Isolation Graphic (Image 1 & 2)

Image 1 & 2 – J3-H, Wire 77 Chaffing, exposed wire causing intermittent connectivity

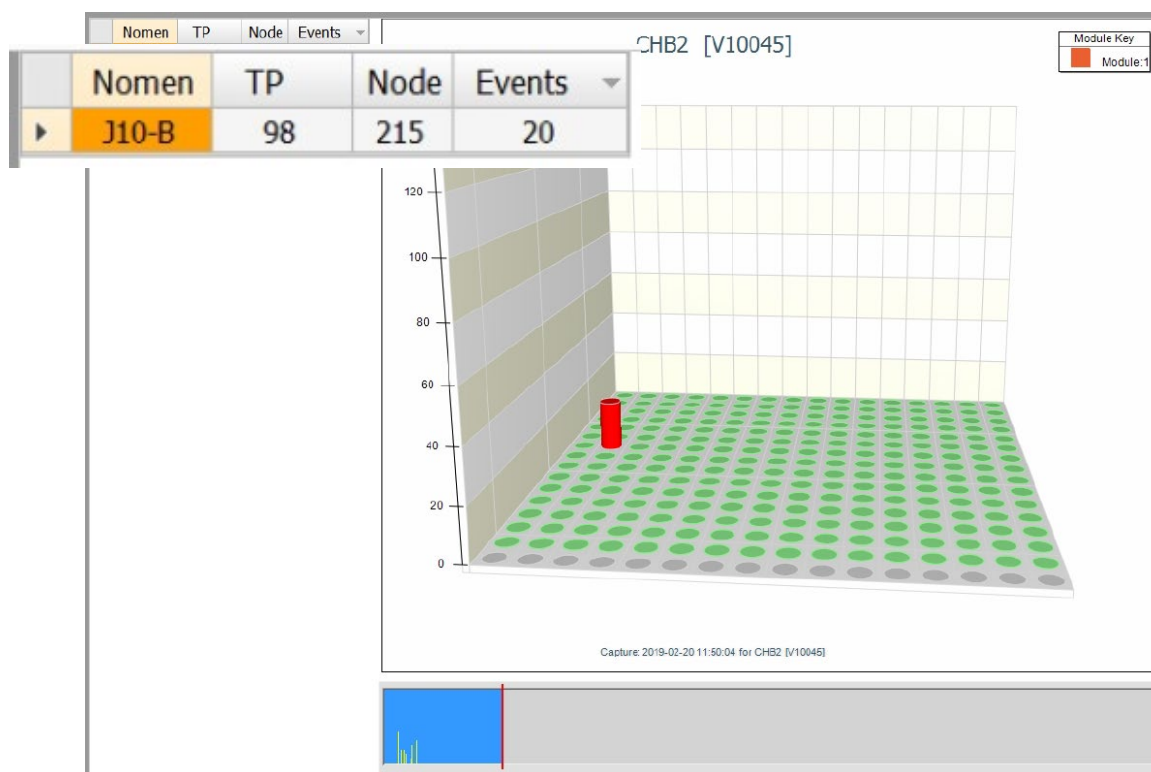
Graphic 3 – GXY (Graphical X/Y Coordinate) View - S/N: V10045 Engine Harness Channel B

1. Voyager continuity testing was conducted, and no open circuits were found in the engine.
2. Voyager shorts testing was conducted, and no shorted circuits were found in the engine.
3. Intermittence testing was conducted, and one circuit experienced 50+ intermittent events on Channel B.
  - a. Location: J10-B, Wire 98, Connected to Node 215 (Graphic 3, screenshot taken at 20 events)

- b. Intermittence Log File (Report 1): Indicates Intermittence Test start time, location of fault (TP#), and time when intermittent fault occurred during test (Adv-Time). Report shows how the maintainer used the Voyager to reconfirm faults. Event or glitch limit was reached at user-selected 50 intermittent events or faults. Data indicates that the user cleared test results several times to reconfirm the trouble area on the harness through manual manipulation confirming intermittent fault on J10-B.

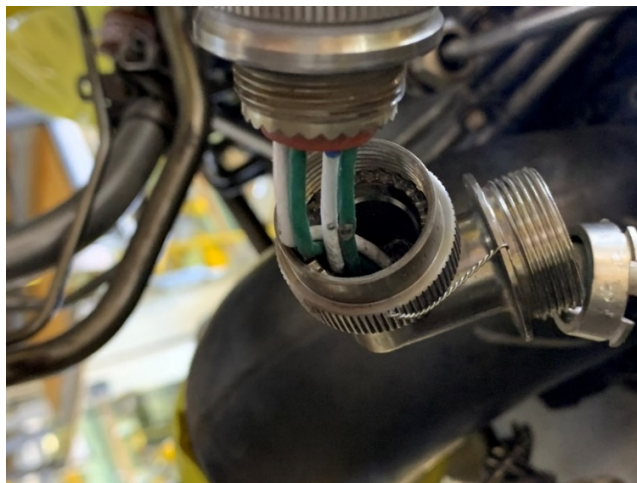
- c. Root Cause Analysis: [REDACTED] engineer was able to diagnose the intermittent fault to root cause based on the Fault Isolation Graphic (Image 3)

Image 3 – J10-B, Wire 98 Chaffing, exposed wire causing intermittent connectivity
