# Intermittent Fault Detection & Isolation System™ (IFDIS™) Technology Demonstration Project

Elevator and Aileron Computer (ELAC)  
Part Number: 3945122505

Universal Synaptics Corp  
4066 South 1900 West Suite B  
Roy, Utah 84067  
801-731-8508

03 January 2013

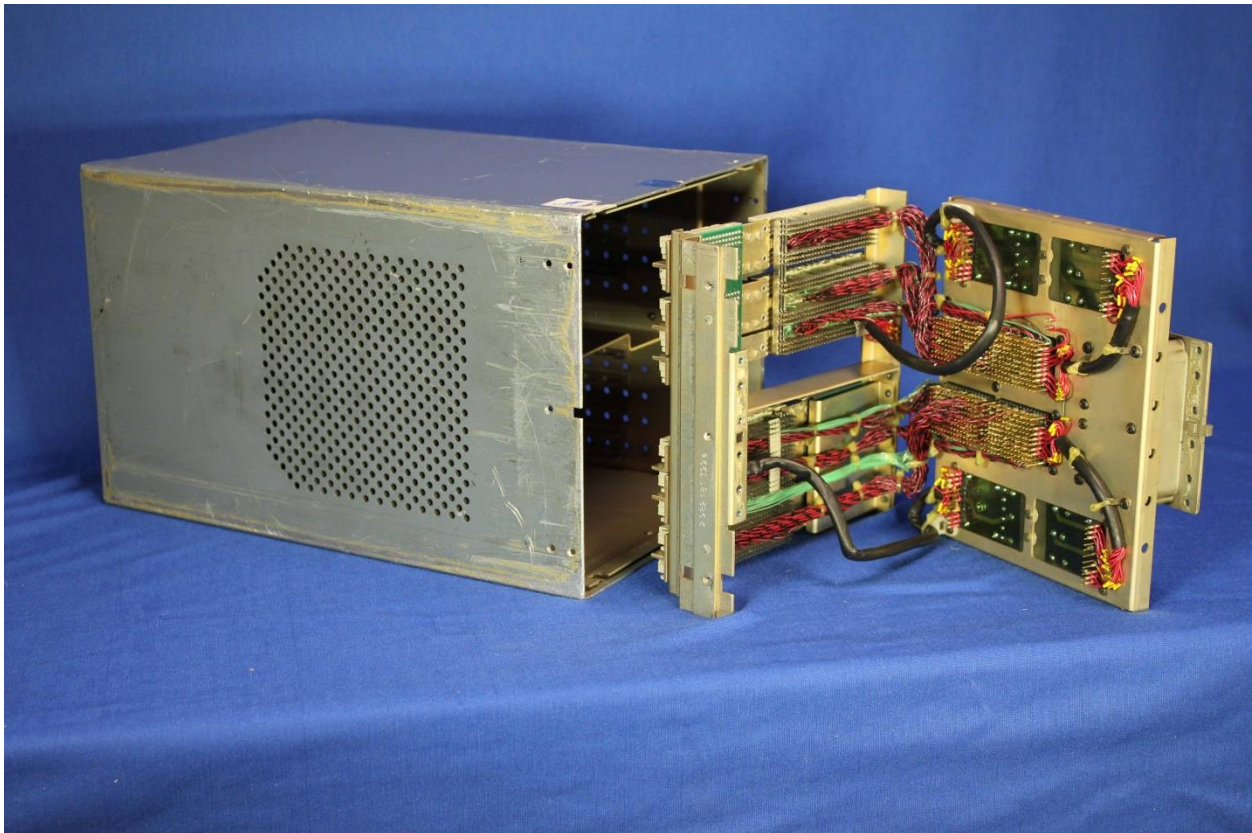
IFDIS Technology Demonstration Test Item - Elevator and Aileron Computer (ELAC)

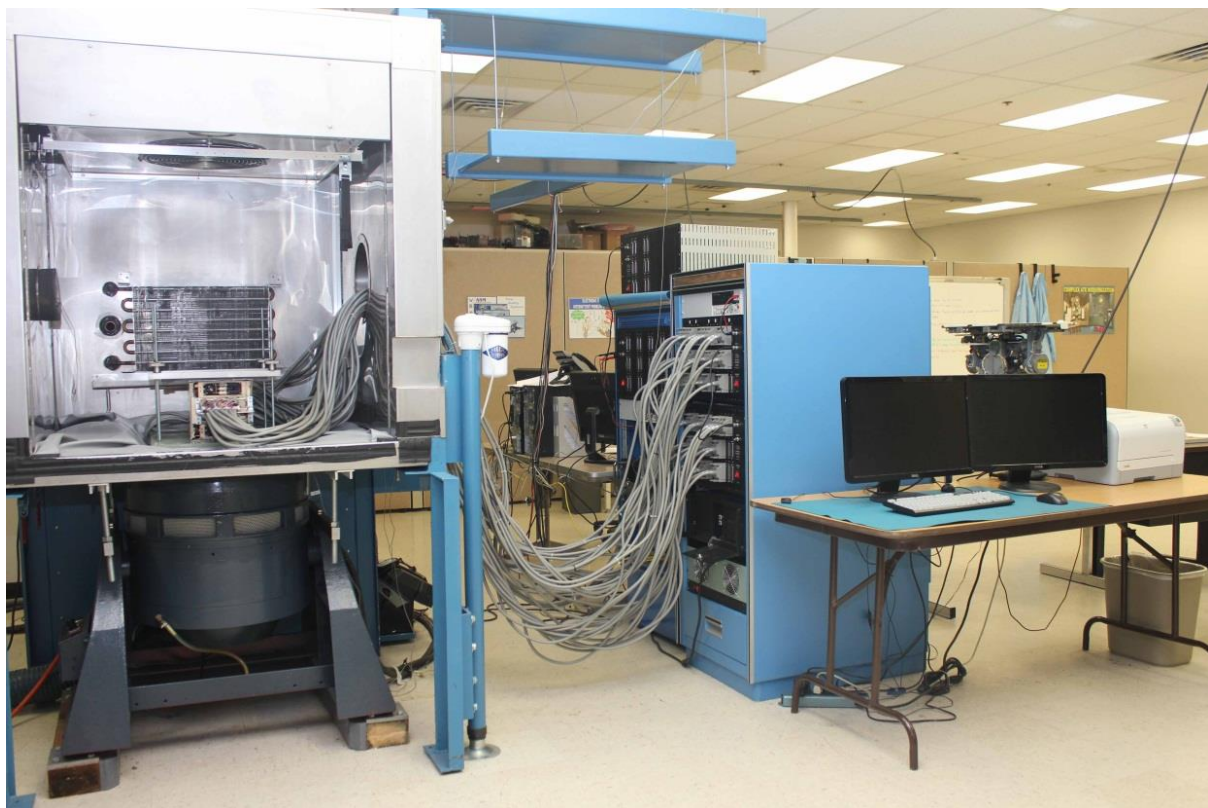
ELAC on the shaker in the environmental chamber connected to the IFD through the ITA

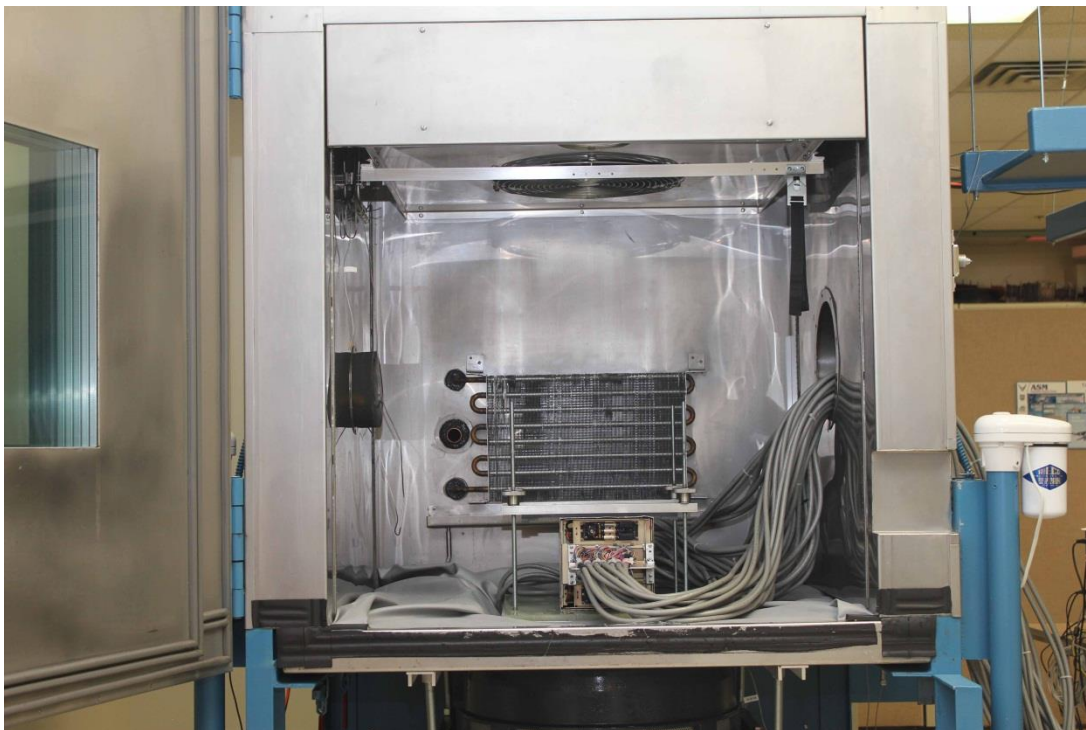
ELAC mounted for testing in the IFDIS environmental chamber

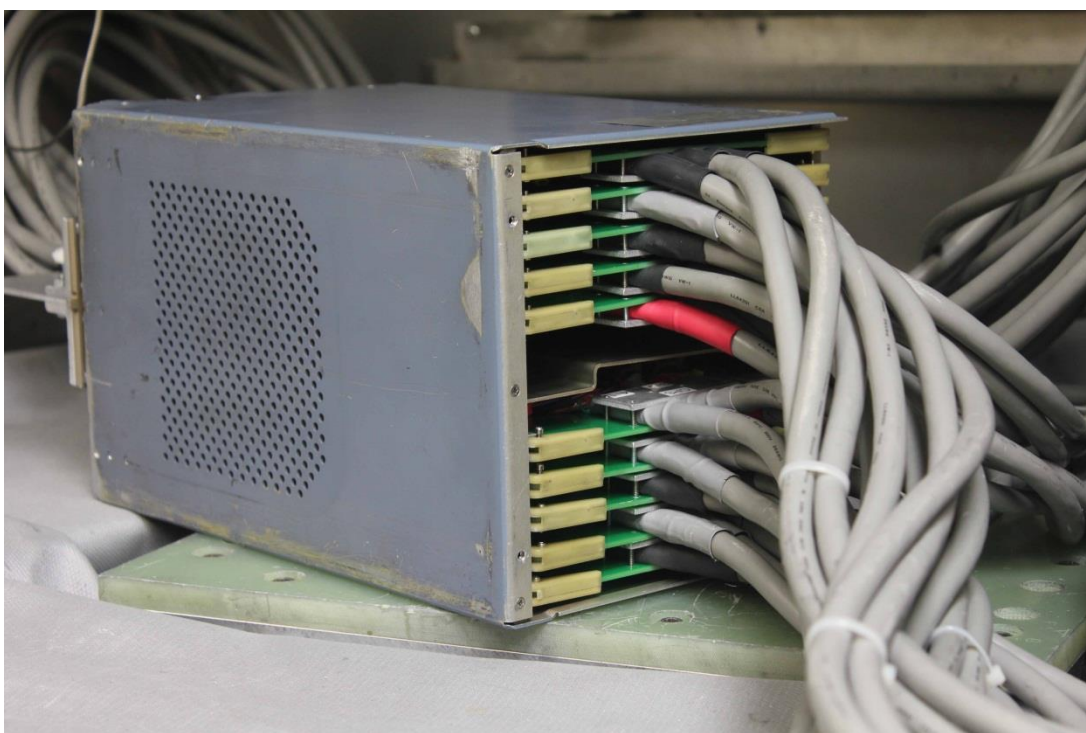
ELAC (rear view) connected to the IFDIS ITA

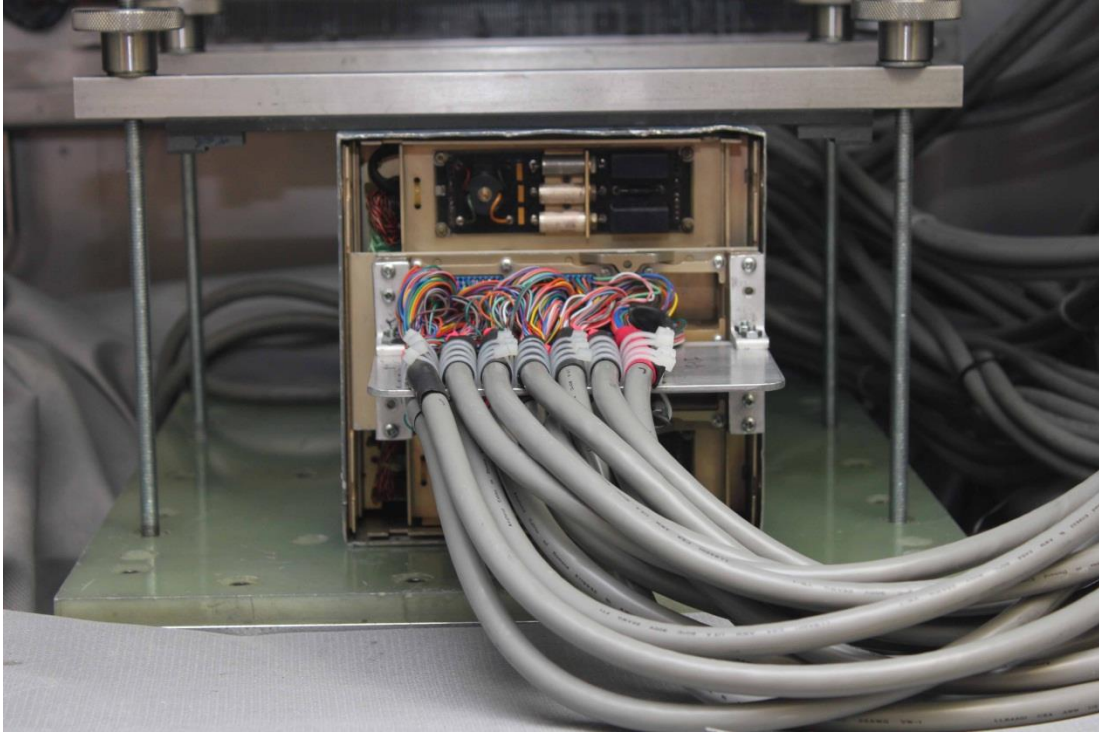
ELAC (front view) on the shaker with the tie down bars and connected to the IFDIS ITA

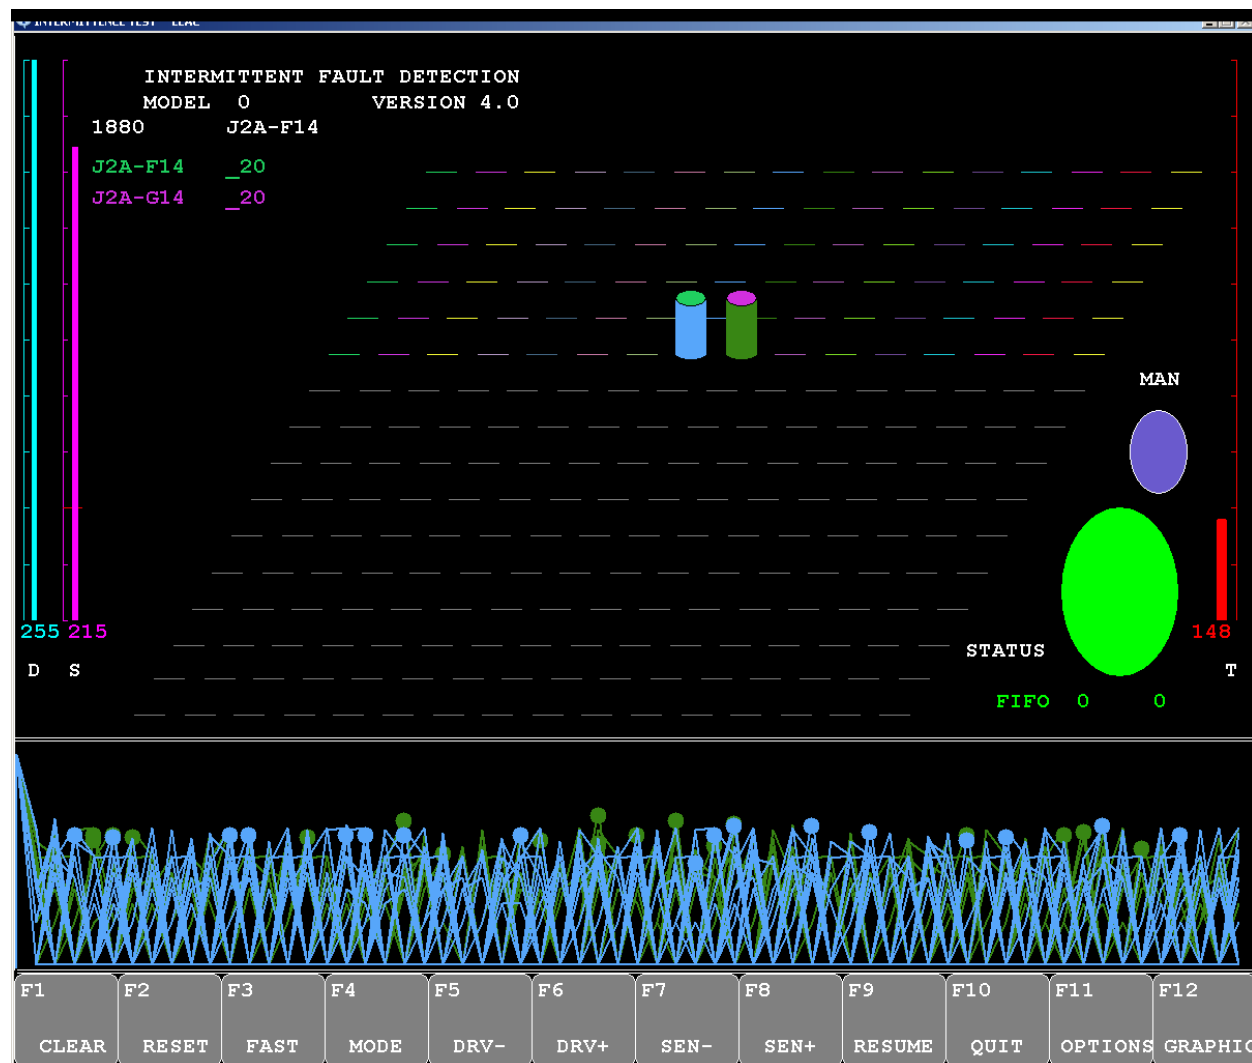
Test Phase	Name	Temperature Degrees Celsius	Test Results & Comments
I	Continuity	Ambient	Passed IFDIS continuity test.
II	Shorts	Ambient	Passed IFDIS shorts test.
III	Vibration - Ambient	Ambient	Passed all IFDIS ambient temperature vibration tests.
IV	Vibration - Cold Soak	-15	<p>A) At 0 deg C and acceptance test vibration, an intermittent fault was detected on the J2A-G14 to CANP1-A26 circuit.</p> <p>B) At -15 deg C and random test vibration, an intermittent fault was detected on the J2A-F14 to CANP1-C19 circuit.</p>
V	Vibration - Heat Soak	70	<p>C) At 58 deg C and sine sweep test vibration, an intermittent fault was detected on the J2A-B2 to CDGP1-C18 circuit.</p> <p>D) At 65 deg C and sine sweep test vibration, an intermittent fault was detected on the J2B-A6 to CPUP1-C21 circuit.</p> <p>E) At 70 deg C and sine sweep test vibration, an intermittent fault was detected on the J1B-E5 to MPSP1-C8 circuit.</p>

For Faults A) and B) from the preceding test results table, the IFDIS Intermittent Fault Detector (IFD) test result screen display is shown in the figure that follows. It indicates that the system detected chassis intermittent faults in the circuits that terminate at J2A-G14 and at J2A-F14.

IFDIS test results example - IFD screen shot of J2A-G14 and J2A-G14 intermittent fault capture for ELAC S/N 6214

VI	Cool Down to Ambient & Disconnect	Ambient	After cool down, the identified circuits were inspected and each wire end was soldered to repair the connection.

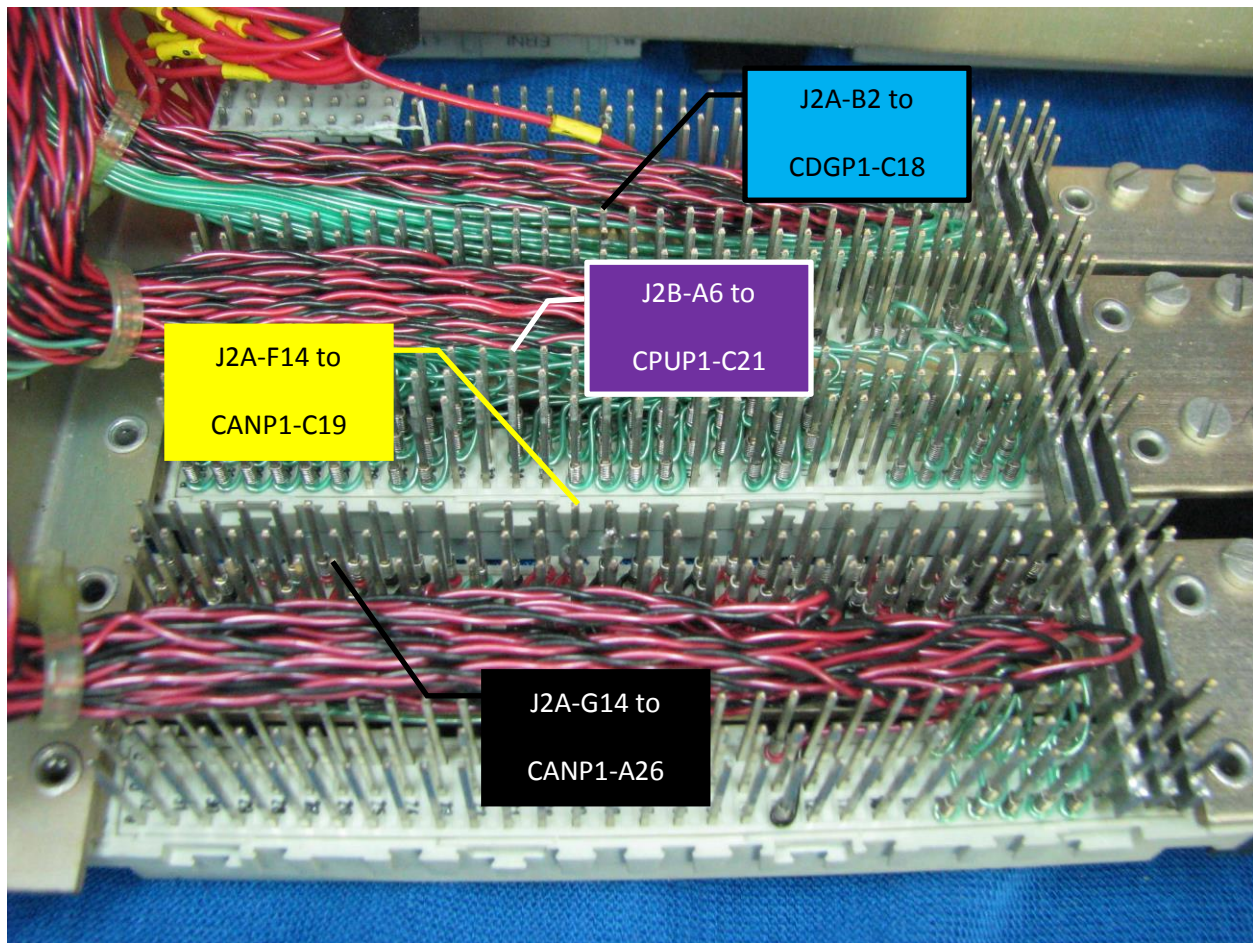
ELAC wire wrap connections for the CSP, CAN, CPU, CDG, and CPS cards  
(Call out boxes indicate wire wrap solder repair locations for ELAC S/N 6214)

**Corrective Actions:** For each intermittent circuit identified, the associated connecting wire end was soldered to its respective terminating post. The ELAC chassis was then retested to verify the circuits were no longer intermittent. The next three photographs show where the wire wrap repairs were made. The locations where the wire wraps were soldered are indicated by the call out boxes and fault circuit designators. The matched colored boxes indicate the locations of both ends of each intermittent circuit that were detected.

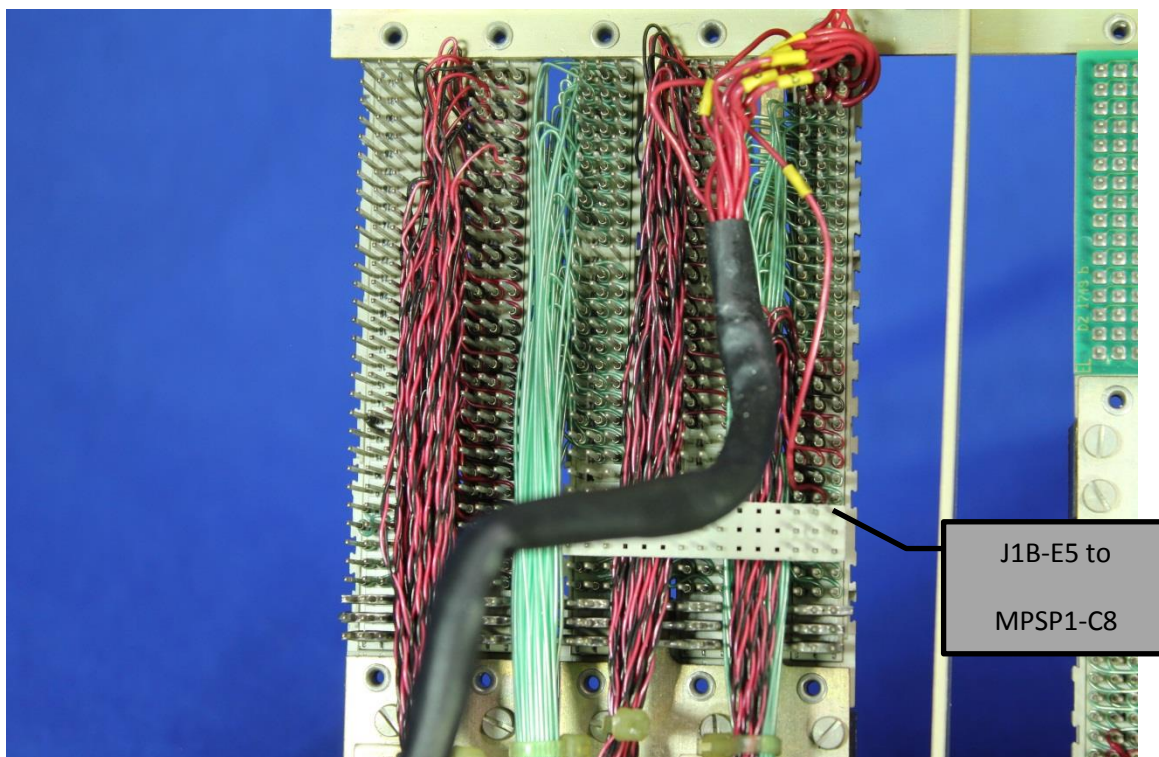
J1B-E5 to  
MPSP1-C8

ELAC wire wrap connections for the MSP, MAN, MPU, MDG, and MPS cards  
(Call out box indicates wire wrap solder repair location for ELAC S/N 6214)

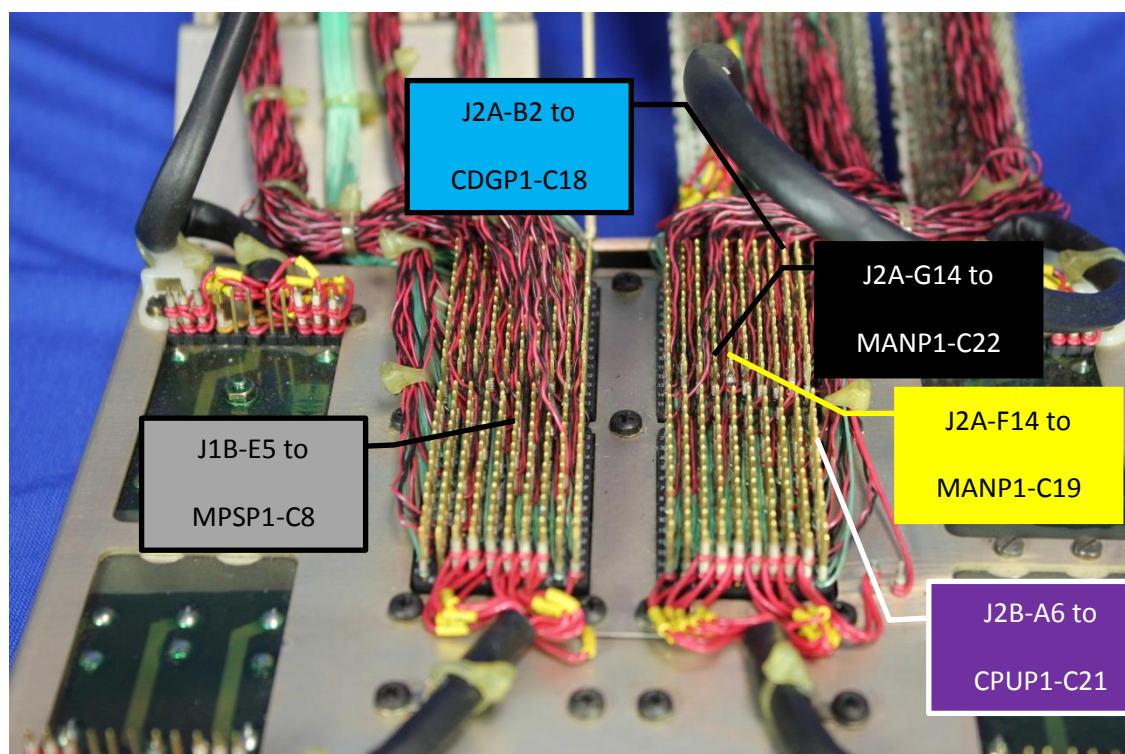
J2A-B2 to  
CDGP1-C18

J2A-G14 to  
MANP1-C22

J2A-F14 to  
MANP1-C19

J2B-A6 to  
CPUP1-C21

J1B-E5 to  
MPSP1-C8

ELAC wire wrap connections for the J1A, J1B, J2A, and J2B connectors  
(Call out boxes indicates wire wrap solder repair locations for ELAC S/N 6214)

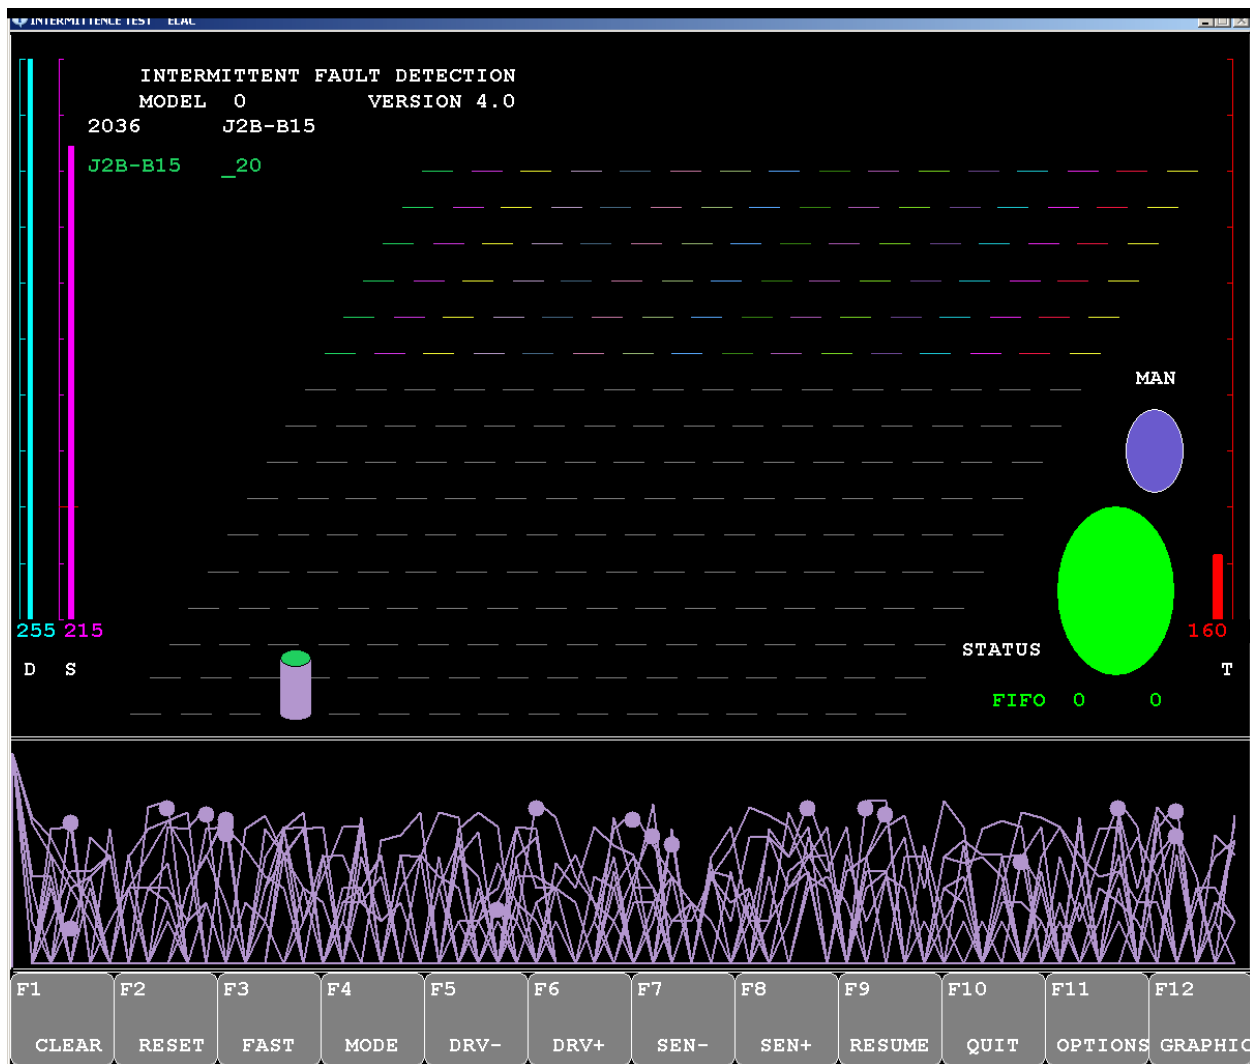
Test Phase	Name	Temperature Degrees Celsius	Test Results & Comments
I	Continuity	Ambient	A) At ambient temperature and no vibration, an open circuit was detected between J2B-B15 and CH-GND. This circuit subsequently tested intermittent during vibration testing.
II	Shorts	Ambient	Passed IFDIS shorts test.
III	Vibration - Ambient	Ambient	Passed all IFDIS ambient temperature vibration tests.
IV	Vibration - Cold Soak	-15	Passed all IFDIS cold soak temperature vibration tests.
V	Vibration - Heat Soak	70	B) At 70 deg C and acceptance test vibration, an intermittent fault was detected on the J1B-E6 to MANP1-A22 circuit.
VI	Cool Down to Ambient & Disconnect	Ambient	After cool down, the identified circuits were inspected and each wire end was soldered to repair the connection.

For Fault A) from the preceding test results table, the IFDIS Intermittent Fault Detector (IFD) test result screen display is presented in the figure that follows. It indicates that the circuit, terminated at J2B-B15, which IFDIS initially detected as open, showed as intermittent during subsequent vibration testing.

IFDIS test results example - IFD screen shot of J2B-B15, which initially showed as an open circuit, but later during vibration, showed as intermittent, for ELAC S/N 5983

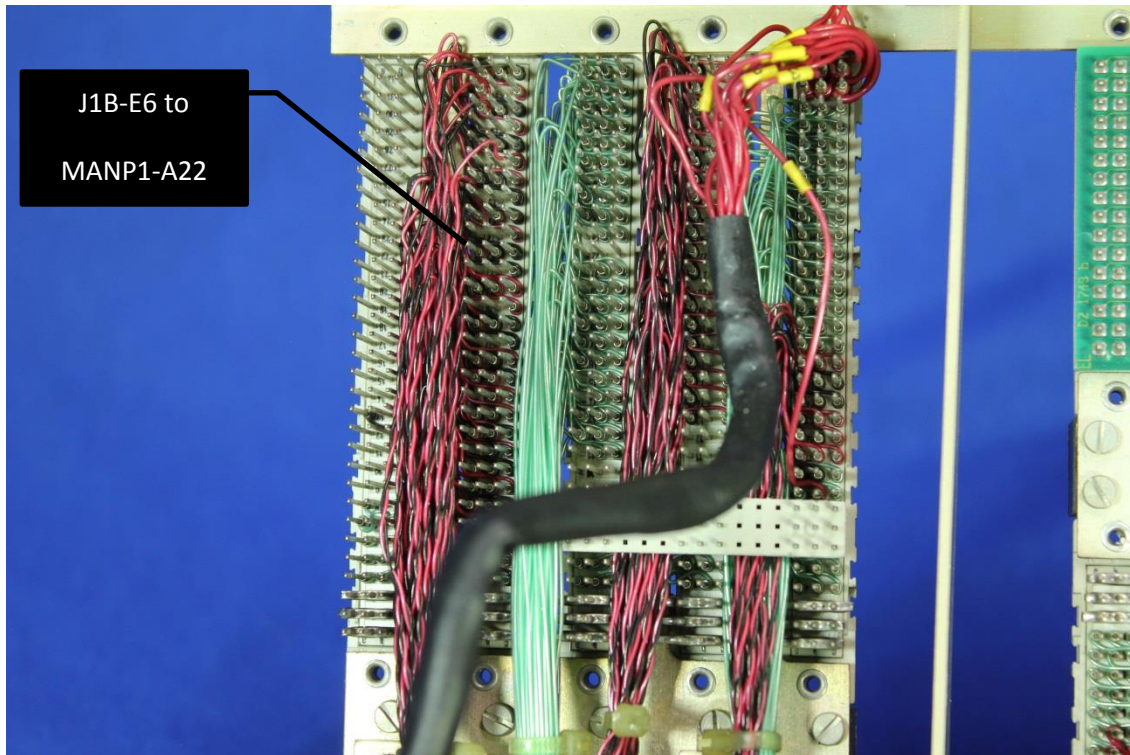
ELAC wire wrap connections for the MSP, MAN, MPU, MDG, and MPS cards  
(Call out box indicates wire wrap solder repair location for ELAC S/N 5983)

**Corrective Actions:** For each failed circuit identified, the associated connecting wire end was soldered to its respective terminating post. The ELAC chassis was then retested to verify proper connectivity. The next two photographs show where the wire wrap repairs were made. The locations where the wire wraps were soldered are indicated by the call out boxes and fault circuit designators. There matched colored boxes indicate the locations of both ends of each intermittent circuit that were detected.

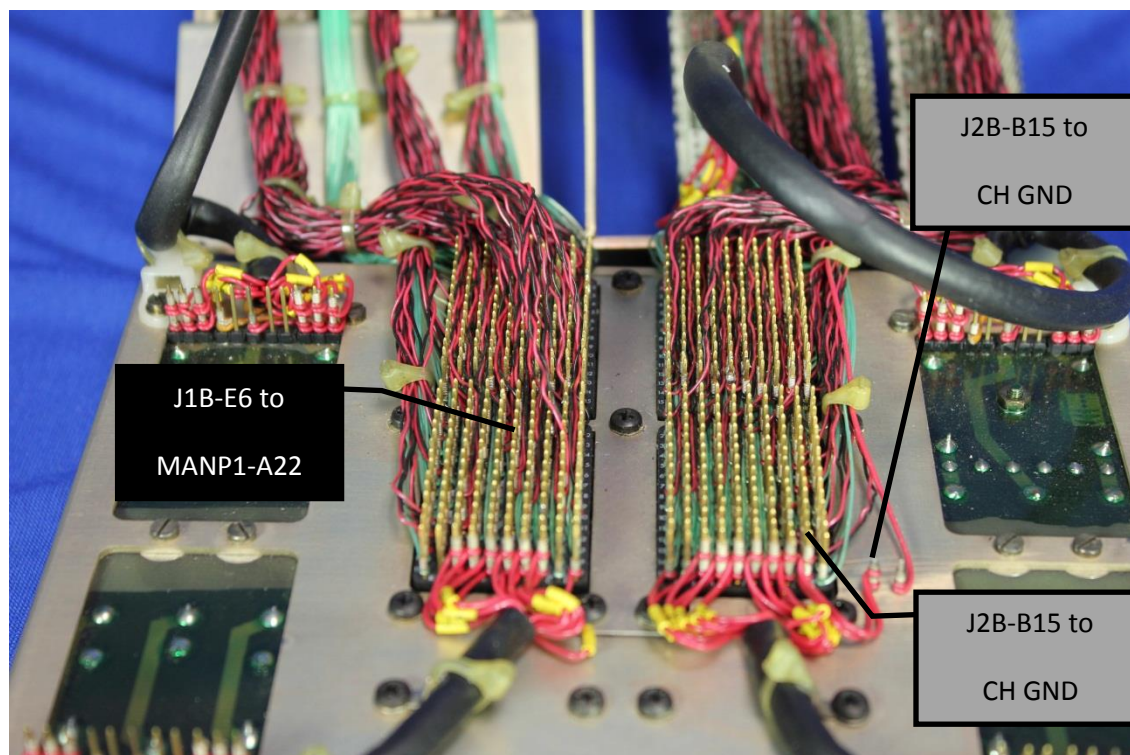
ELAC wire wrap connections for the J1A, J1B, J2A, and J2B connectors  
(Call out boxes indicate wire wrap solder repair locations for ELAC S/N 5983)

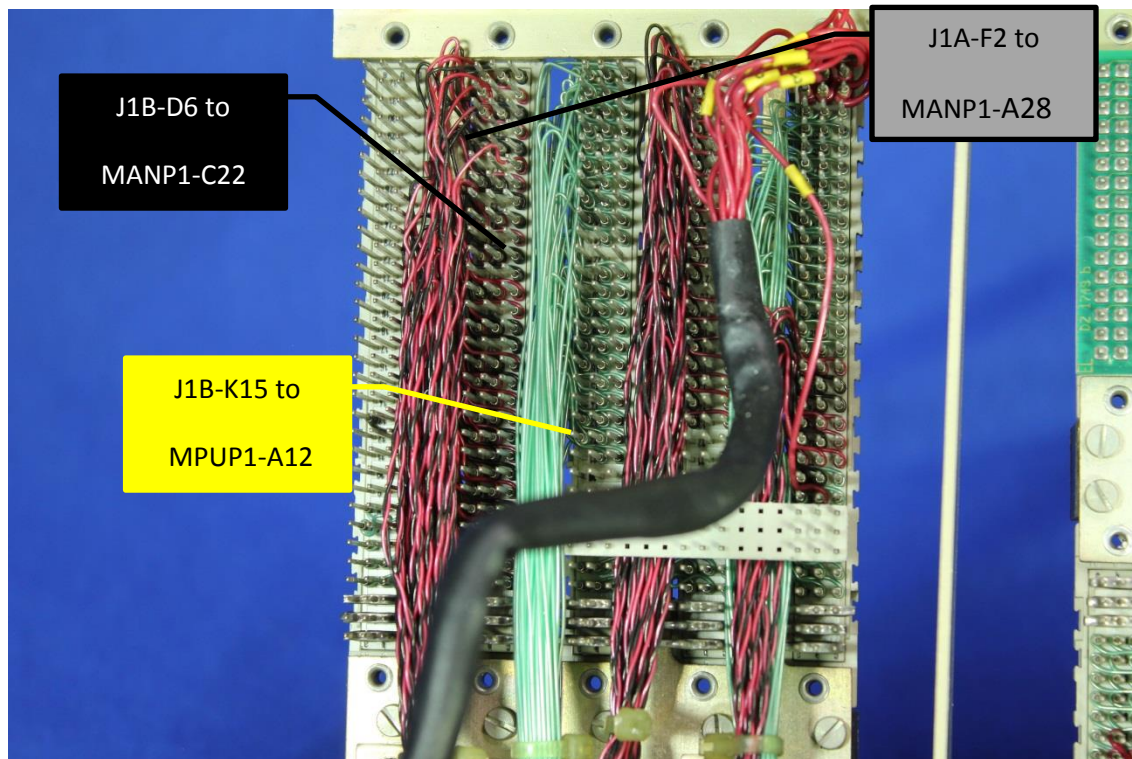
Test Phase	Name	Temperature Degrees Celsius	Test Results & Comments
I	Continuity	Ambient	Passed IFDIS continuity test.
II	Shorts	Ambient	Passed IFDIS shorts test.
III	Vibration - Ambient	Ambient	Passed all IFDIS ambient temperature vibration tests.
IV	Vibration - Cold Soak	-15	A) At -15 deg C and acceptance test vibration, an intermittent fault was detected on the J1B-D6 to MANP1-C22 circuit. B) At -15 deg C and acceptance test vibration, an intermittent fault was detected on the J1A-F2 to MANP1-A28 circuit.
V	Vibration - Heat Soak	70	C) At 70 deg C and acceptance test vibration, an intermittent fault was detected on the J1B-K15 to MPUP1-A12 circuit.
VI	Cool Down to Ambient & Disconnect	Ambient	After cool down, the identified circuits were inspected and each wire end was soldered to repair the connection.

ELAC wire wrap connections for the MSP, MAN, MPU, MDG, and MPS cards  
(Call out boxes indicate wire wrap solder repair locations for ELAC S/N 6331)

**Corrective Actions:** For each intermittent circuit identified, the associated connecting wire end was soldered to its respective terminating post. The ELAC chassis was then retested to verify the circuits were no longer intermittent. The next two photographs show where the wire wrap repairs were made. The locations where the wire wraps were soldered are indicated by the call out boxes and fault circuit designators. The matched colored boxes indicate the locations of both ends of each intermittent circuit that was detected.

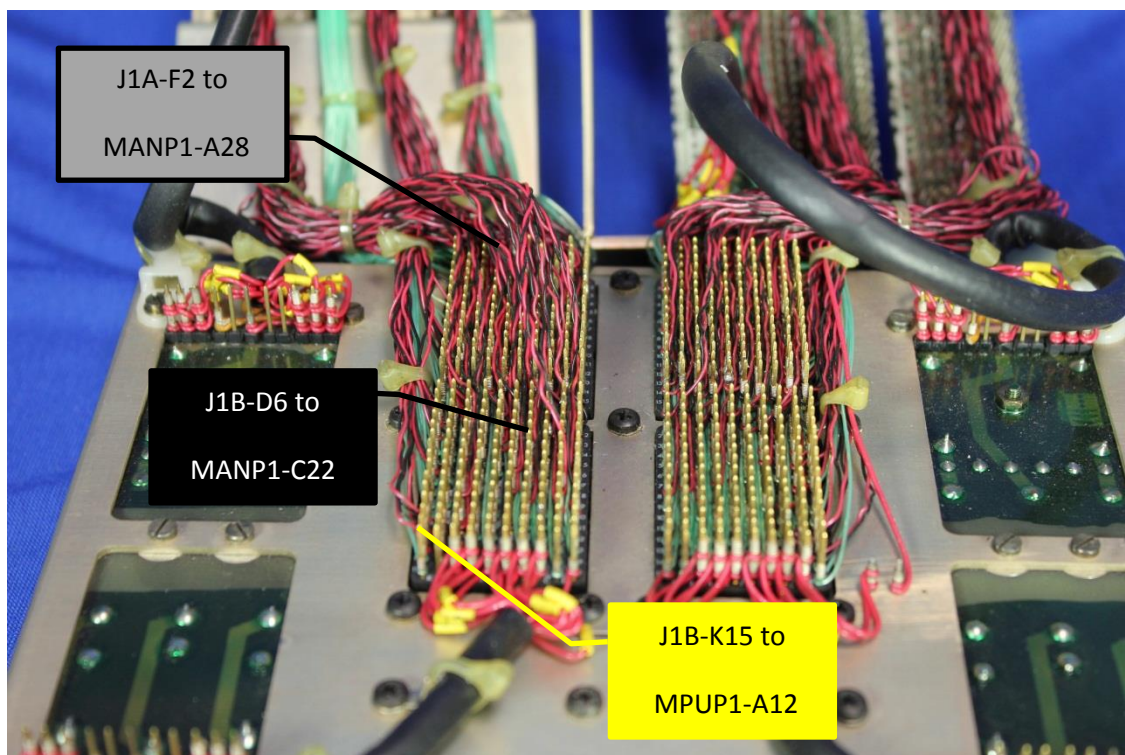
ELAC wire wrap connections for the J1A, J1B, J2A, and J2B connectors  
(Call out boxes indicate wire wrap solder repair locations for ELAC S/N 6331)

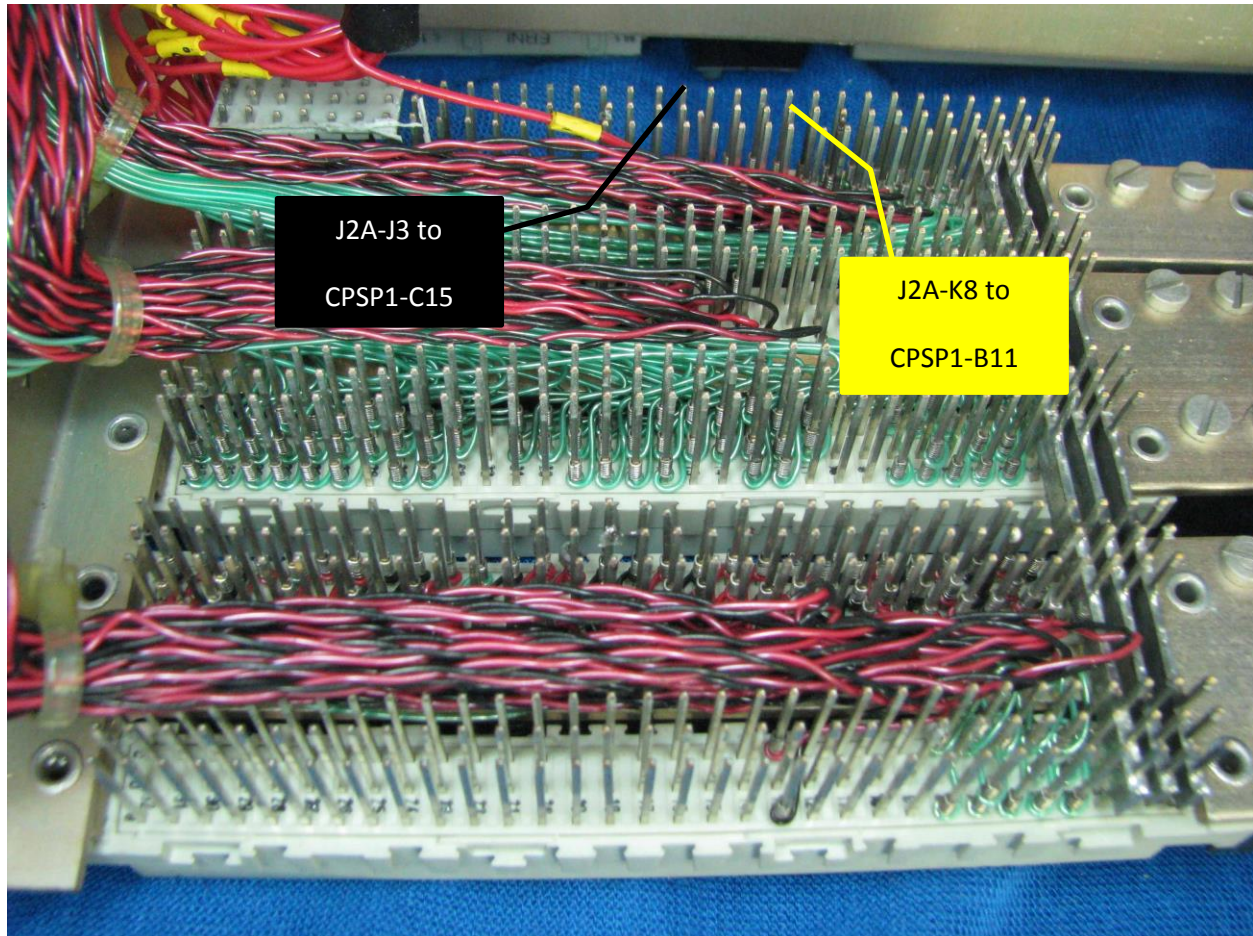
Test Phase	Name	Temperature Degrees Celsius	Test Results & Comments
I	Continuity	Ambient	Passed IFDIS continuity test.
II	Shorts	Ambient	A) During the IFDIS shorts test, a short to ground was detected on the J1B-F15 to MPSP1-C32 circuit.
III	Vibration - Ambient	Ambient	Passed all IFDIS ambient temperature vibration tests.
IV	Vibration - Cold Soak	-15	Passed all IFDIS cold soak temperature vibration tests.
V	Vibration - Heat Soak	70	B) At 70 deg C and sine sweep test vibration, an intermittent fault was detected on the J2A-K8 to CPSP1-B11 circuit. C) At 70 deg C and sine sweep test vibration, an intermittent fault was detected on the J2A-J3 to CPSP1-C15 circuit. D) At 70 deg C and sine sweep test vibration, an intermittent fault was detected on the J1B-D6 to MANP1-C22 circuit.
VI	Cool Down to Ambient & Disconnect	Ambient	After cool down, the identified circuits were inspected and each wire end was soldered to repair the intermittent connections. The short circuit was corrected by repairing and then repositioning a sheath covered wire bundle so that it would no longer be penetrated by a wire wrap pin.

ELAC wire wrap connections for the CSP, CAN, CPU, CDG, and CPS cards  
(Call out boxes indicate wire wrap solder repair locations for ELAC S/N 2070)

**Corrective Actions:** For each intermittent circuit identified, the associated connecting wire end was soldered to its respective terminating post. The next three photographs

show where the wire wrap repairs were made. The locations where the wire wraps were soldered are indicated by the call out boxes and fault circuit designators. The matched colored boxes indicate the locations of both ends of each intermittent circuit that was detected.

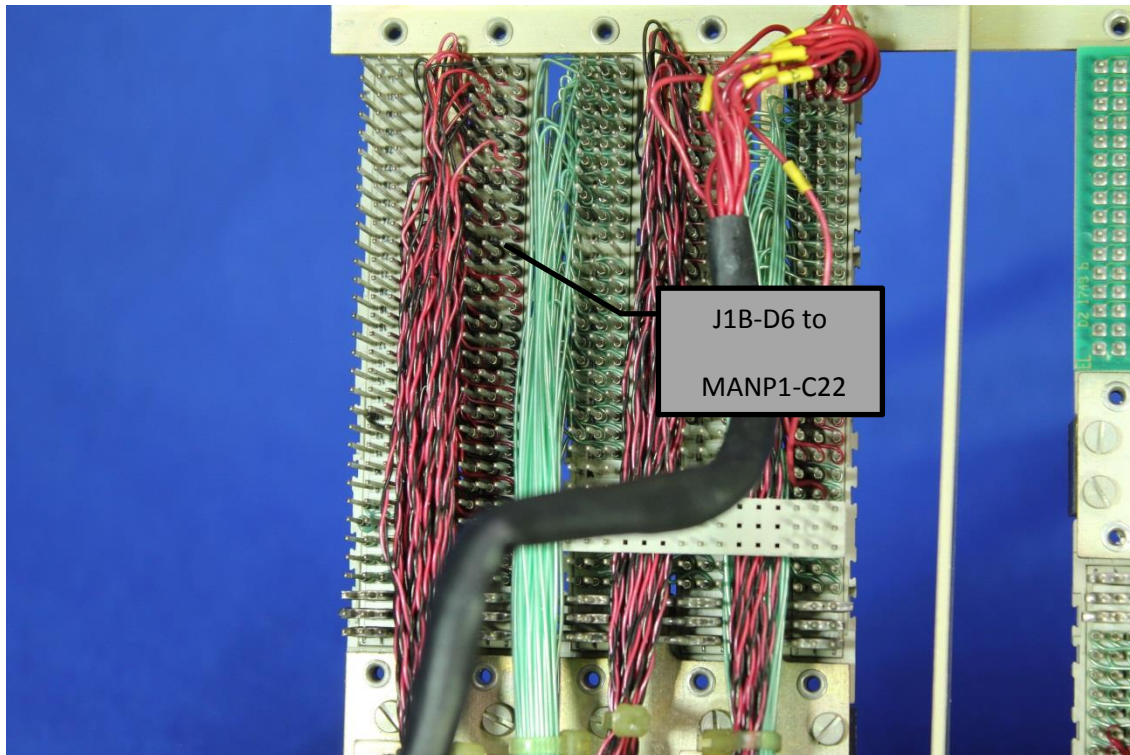
J1B-D6 to  
MANP1-C22

ELAC wire wrap connections for the MSP, MAN, MPU, MDG, and MPS cards  
(Call out box indicates wire wrap solder repair location for ELAC S/N 2070)

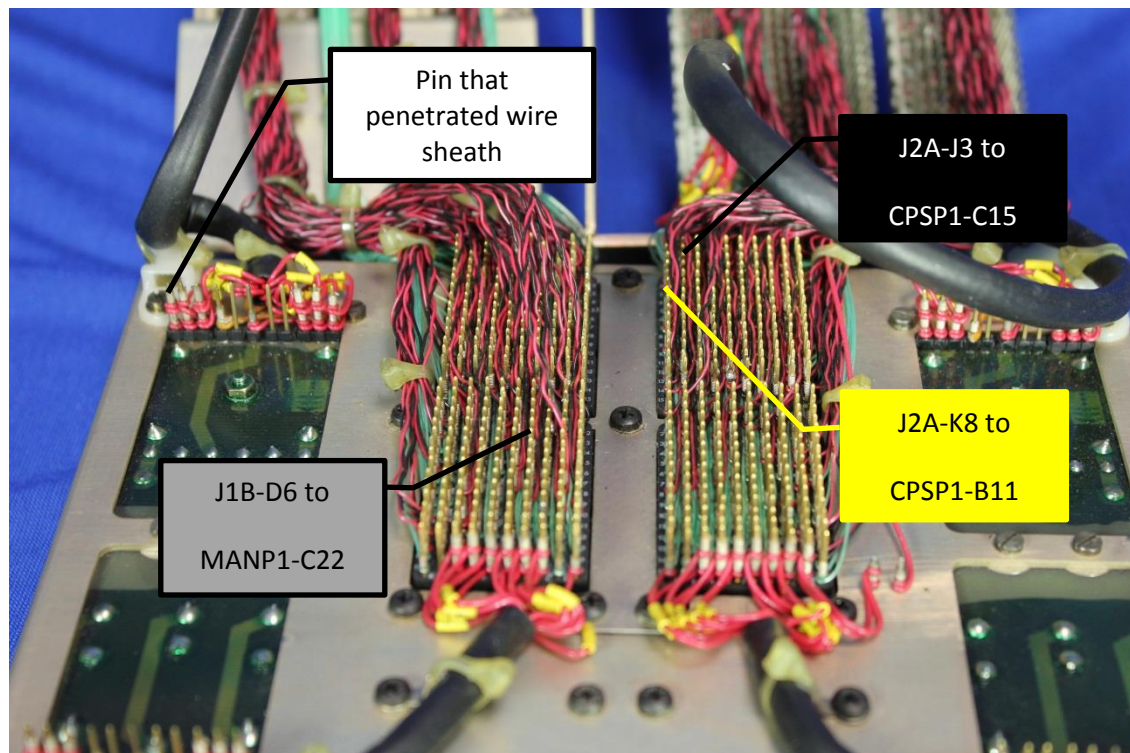
It should be noted that a circuit was found to be shorted. The problem was diagnosed and it was found that one of the wire wrap pins had penetrated a wire bundle sheath and contacted a grounded wire braid within. As the pin made contact with the braid inside the sheath, the circuit tied to that pin was shorted to ground.

Pin that  
penetrated wire  
sheath

J2A-J3 to  
CPSP1-C15

J2A-K8 to  
CPSP1-B11

J1B-D6 to  
MANP1-C22

ELAC wire wrap connections for the J1A, J1B, J2A, and J2B connectors  
(Call out boxes indicate wire wrap solder repair locations for ELAC S/N 2070)

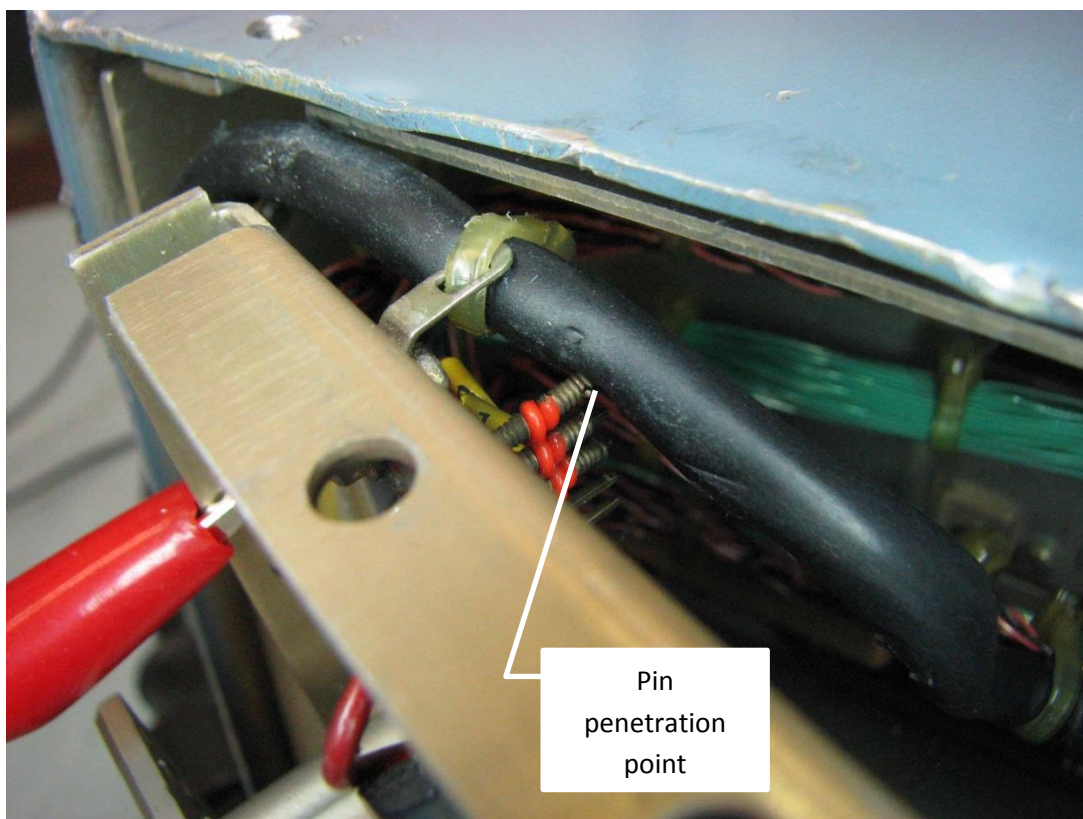
The next photographs illustrate the ELAC chassis short circuit. As highlighted earlier, it was found that a wire wrap pin had penetrated the wire bundle sheath and was pressing against a grounded braid within the sheath. This shorted to ground the circuit tied to that pin. The bundled wires were inspected to determine if the penetrating pin had damaged any wires within the bundle, but none were damaged. The sheath on the bundled wires was repaired. A new and better wire bundle tie down was installed, obtained from the electronic assembly which was cannibalized for parts. This new tie down routes the wire bundle around the wire wrap pins. Because the wire wrap on the penetrating pin was somewhat unwrapped, that pin was also soldered.

Wire wrap pin penetrating a wire bundle sheath, shorting that circuit to the grounded braid inside – ELAC S/N 2070

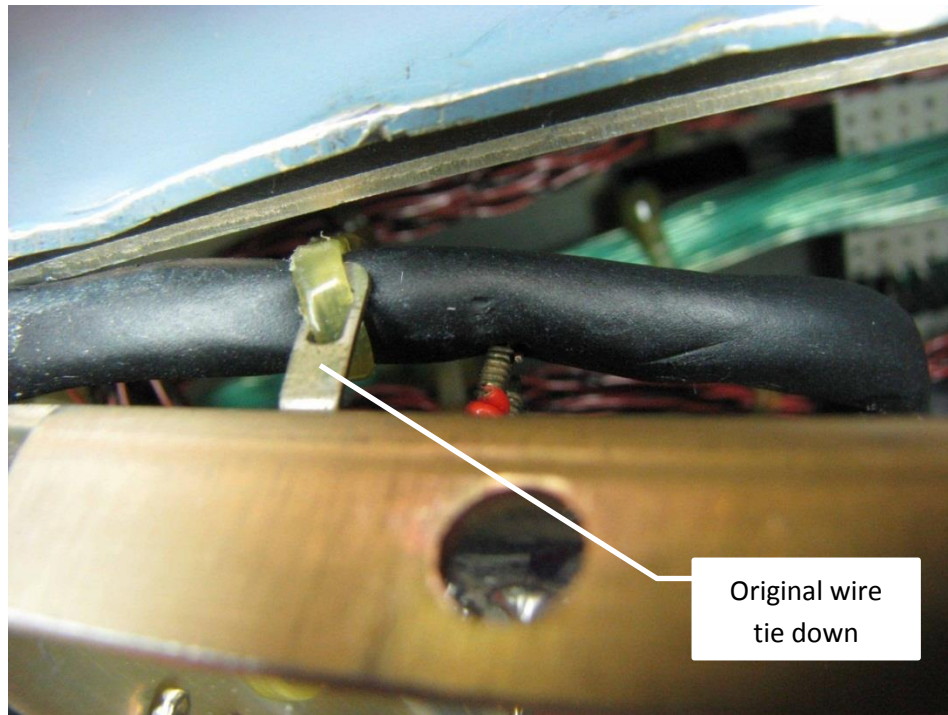
Original wire  
tie down

Wire bundle tie down near wire wrap pin penetrating a wire bundle sheath –  
ELAC S/N 2070

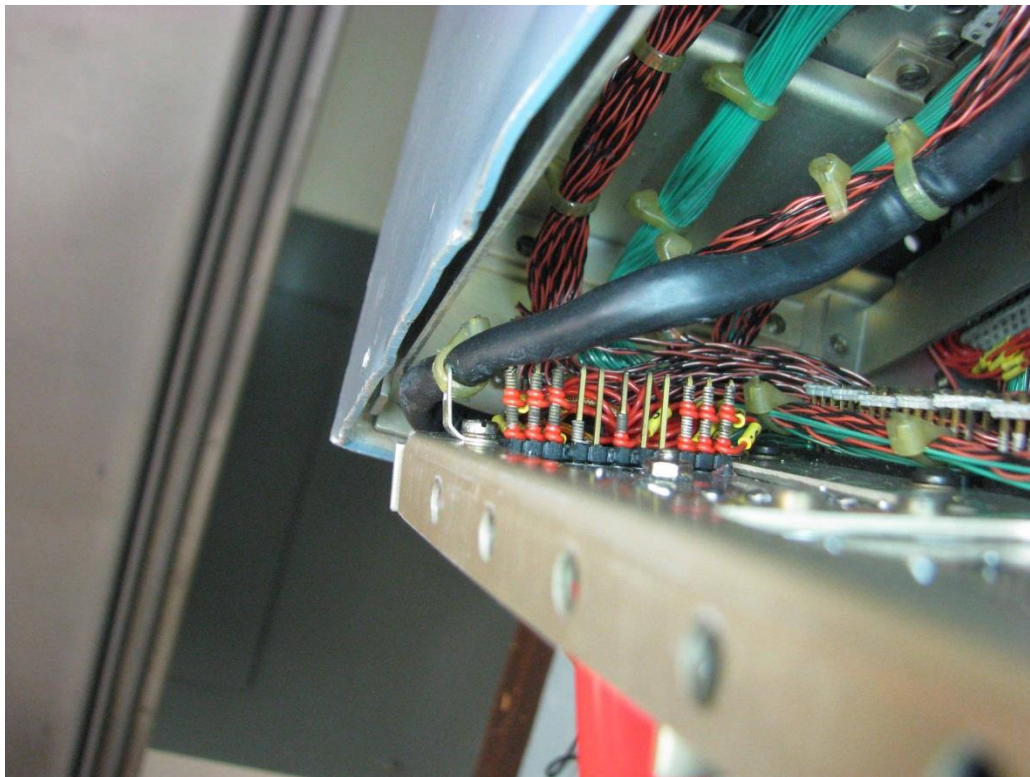
Wire wrap pin penetrating a wire bundle sheath – ELAC S/N 2070

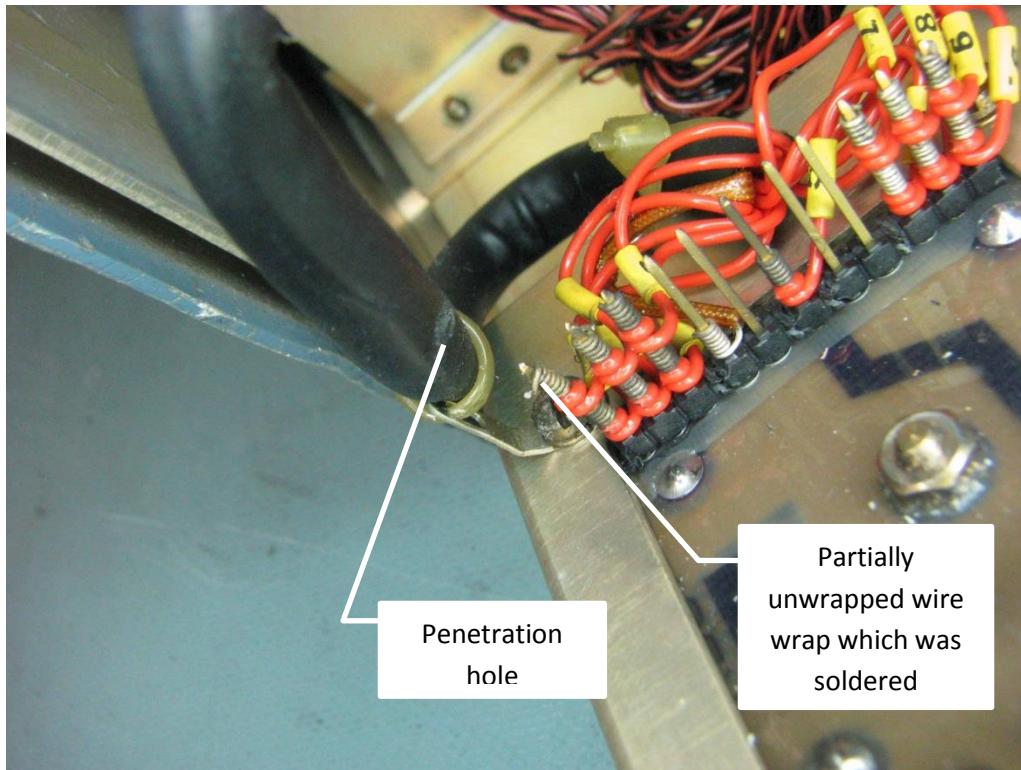
Wire wrap pin penetrated a wire bundle sheath – ELAC S/N 2070
