Intermittent Fault Detector™ (IFD-256™)

Customer Removed – Boeing 777 GE90 Engine Harness Wire Bundle Assembly 286W0751-302 / 286W0752-302 Test Summary

18 March 2020

Wire Bundle Assembly (286W0751-302 / 286W0752-302) S/N: 6693415

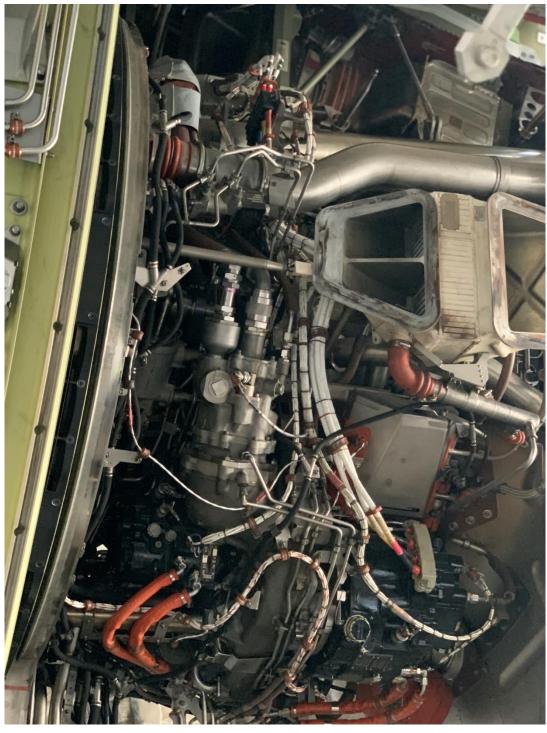
Graphic 8 – Wire Bundle Assembly installed on GE90 Engine on Aircraft – in situ testing is preferable to allow UUT to function in installed environment to simulate real world environment
